**Line of Duty Death  
Investigative Report**

**Technician I Kyle Wilson**

**15474 Marsh Overlook Structure Fire  
April 16, 2007**

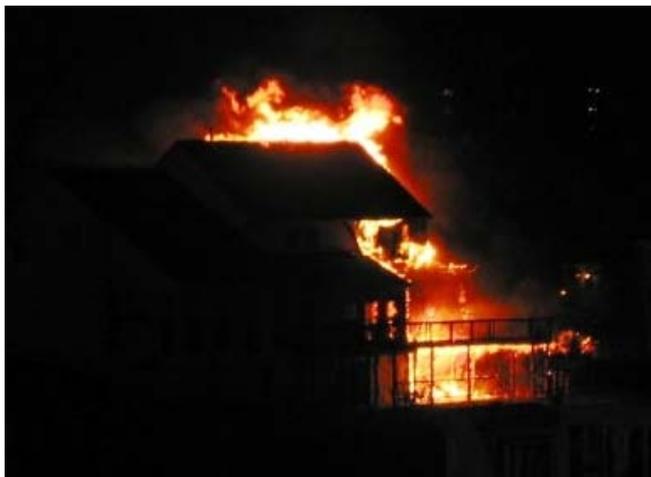
**Side C view from neighbor's house Eiderdown Ct.  
prior to arrival of fire and rescue units**

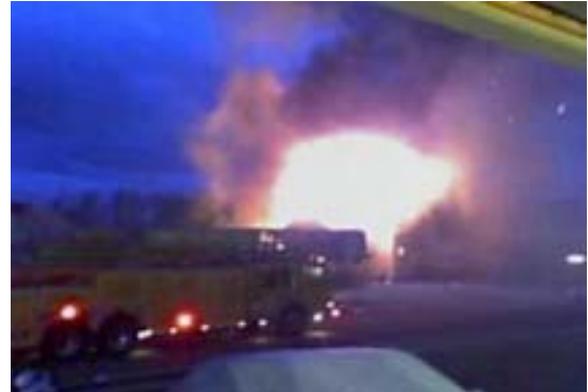
**Tower 512 arrives on scene – Side B**

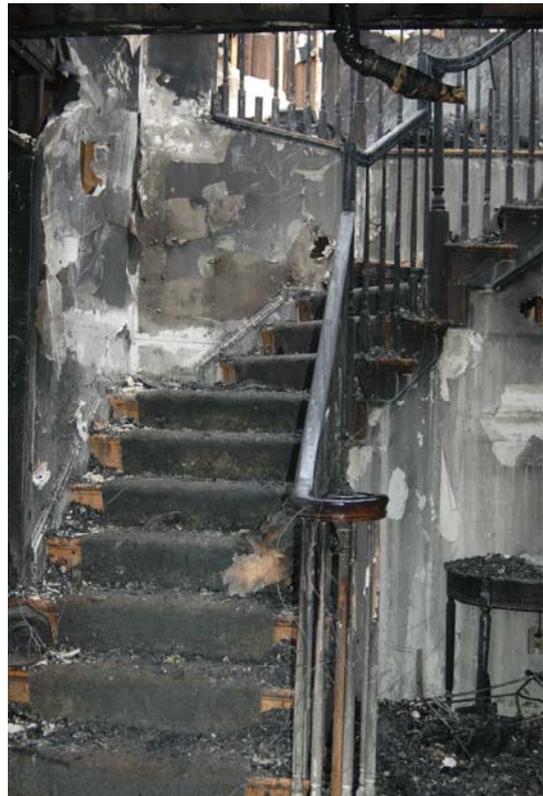
**Foyer stairs to the second floor**

down five to six stairs. The officer's right elbow penetrated the wall board at the curve of the staircase which stopped the officer's descent down the stairs. The officer immediately yelled back to Technician Wilson who was still on the second floor. The officer stated that Technician Wilson verbally communicated back that he could not find the stairs. The officer replied back for Technician Wilson to come toward the officer's voice and shined a flashlight toward the top of the landing area of the staircase.

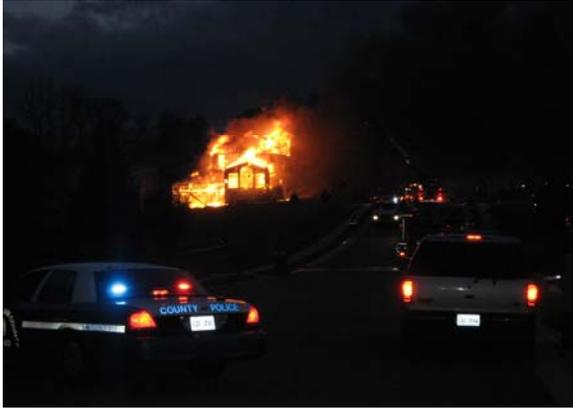
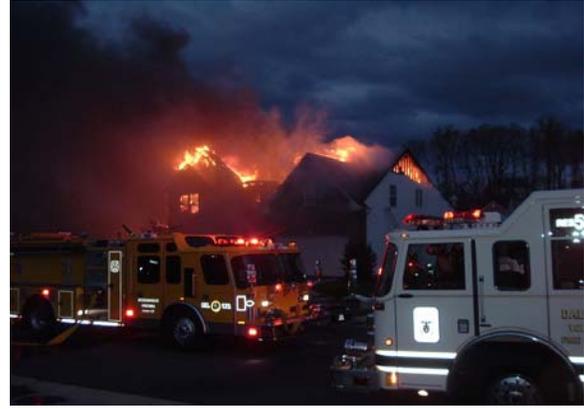
**Side B**  
**Side A/D**  
**Intense fire and heat conditions are throughout the structure**

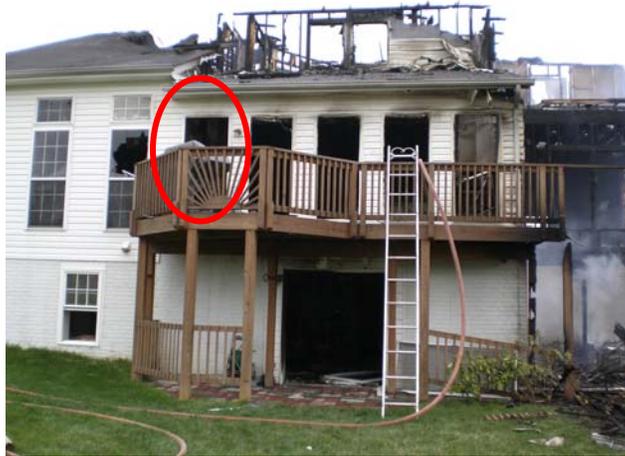
**Wagon 502 entry point on Side C;  
Red circle notes the entry point**

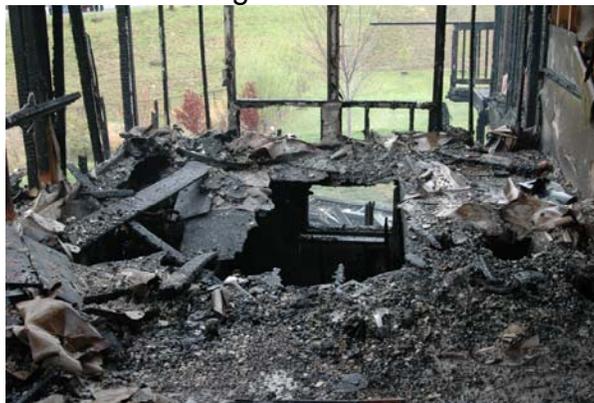
**First floor burn through in Quadrant Bravo  
(Dining room)**

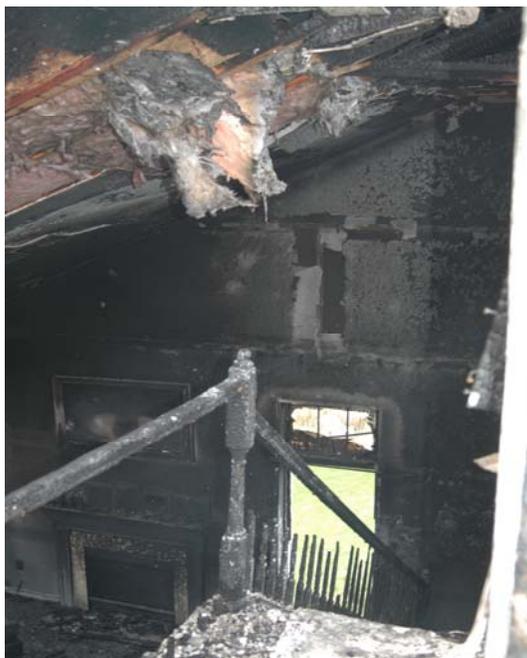
**Rear staircase from family room**

Engine 513 entered on Side D and was able to ascend a second staircase located in the family room between Quadrants Charlie and Delta. The officer was able to breach the family room dry wall into the master suite area and performed a visual check through the hole made into the master bathroom. Not locating the missing firefighter, the crew moved further up the rear staircase and breached a second location. The second hole was breached into the master bedroom from the staircase drywall but a visual check was limited because of the intense fire and smoke conditions present in the master bedroom area. The area was swept with a thermal imaging camera but no shapes were identified on the screen because the room contained extremely high heat conditions.

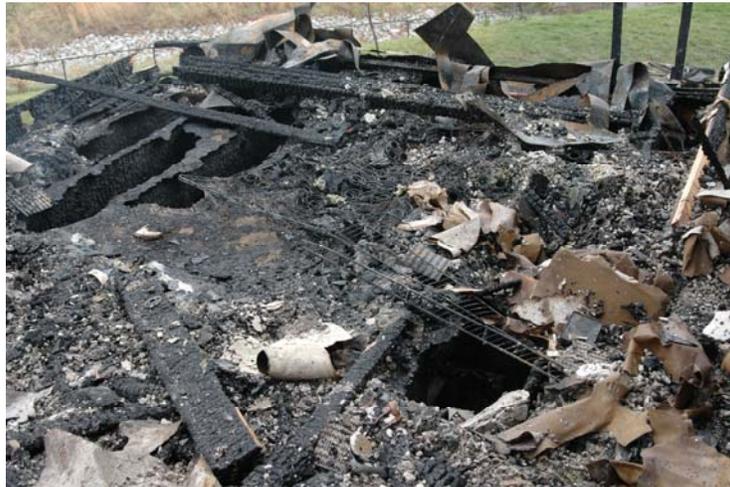
RIT Command transmitted that crews were searching the second floor in the area of the collapse. RIT Command reported to Command that the collapse was in the upper bedroom in Quadrant Bravo and the crews had attempted to search the area, but the structure collapse was significant and the search could not be continued.

**Collapse and hole burn through of second floor bedroom in Quadrant Bravo**
