**Line of Duty Death  
Investigative Report**

**Technician I Kyle Wilson**

**15474 Marsh Overlook Structure Fire  
April 16, 2007**

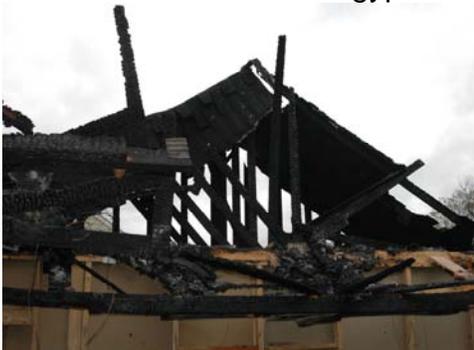
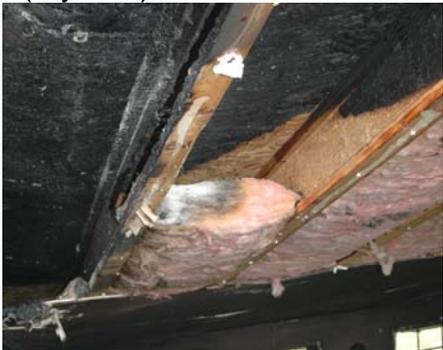
<p>Fiberglass shingles</p> <p>Underlayment</p> <p>7/16 inch Weyerhaeuser Structurwood® Sheathing</p> <p>Fiberglass insulation</p> <p style="text-align: center;"><u>Roof framing:</u></p> <p>2-story Family Room Area – Engineered I-beams; Eat-in Kitchen Area – Solid Wood 2x12; Remaining Areas – 2x4 Trusses</p> <p style="text-align: center;">½ inch gypsum wall board (dry wall)</p>

2x4 Trusses	Engineered I-beams

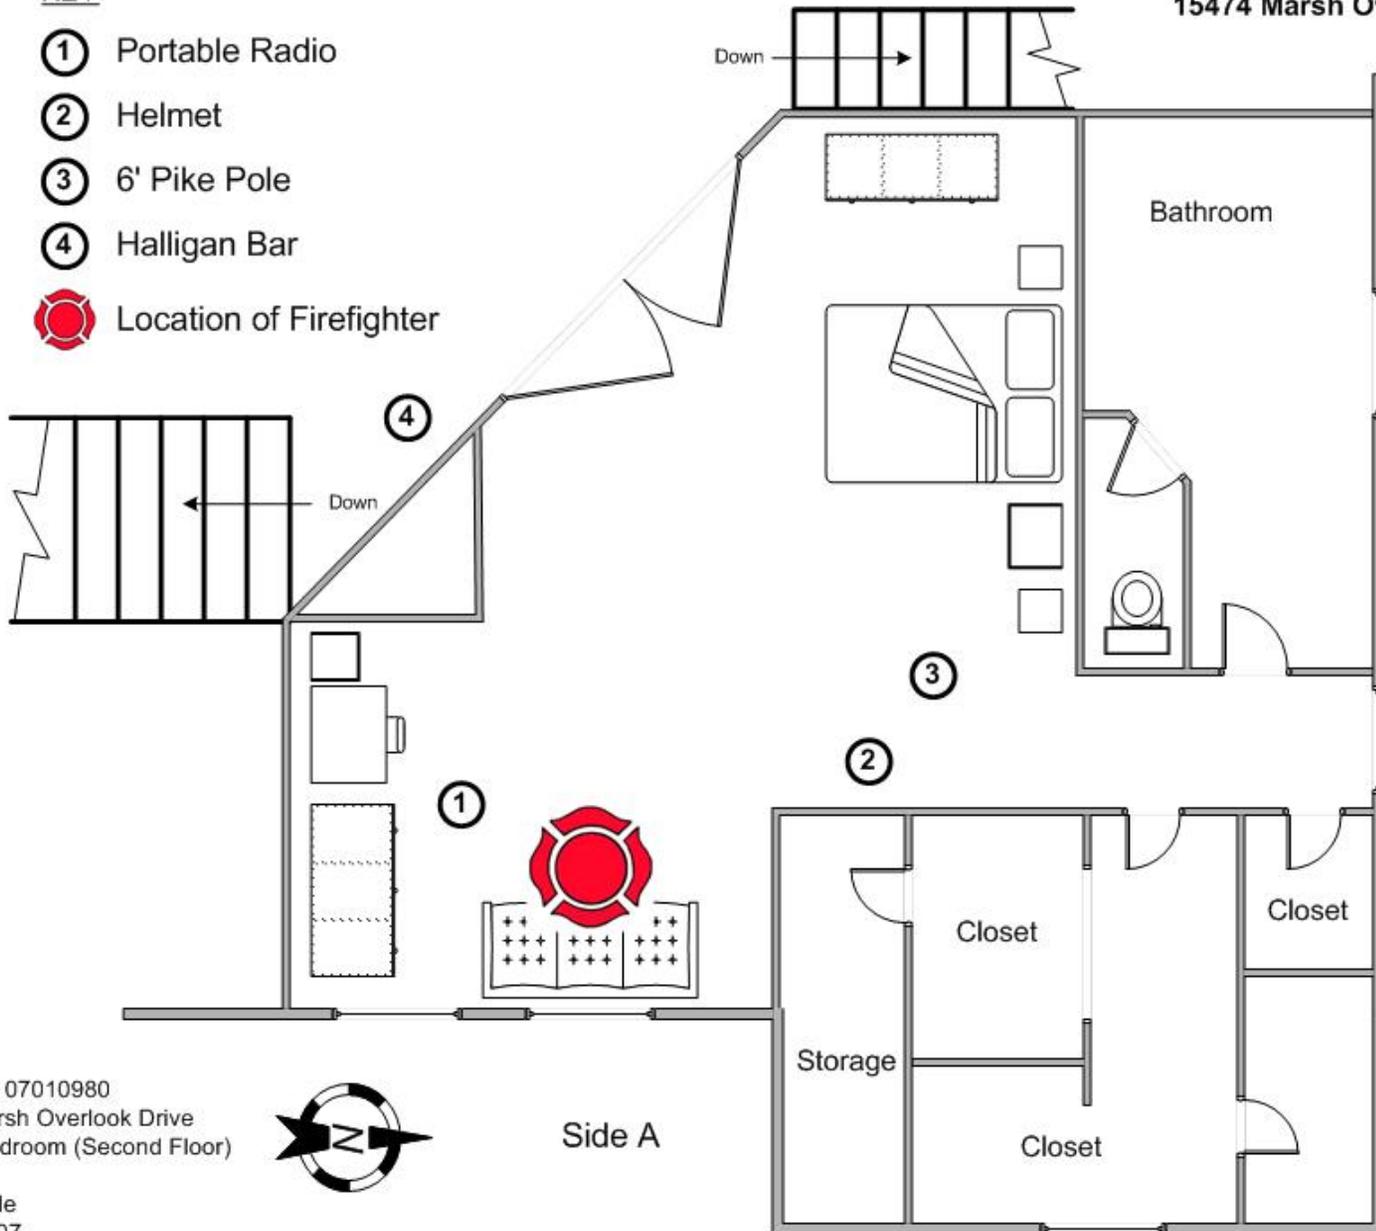
PWCFD#: 07010980  
15474 Marsh Overlook Drive  
Master Bedroom (Second Floor)  
4/16/07  
Not to scale  
JBC 12/4/07

Location of Firefighter

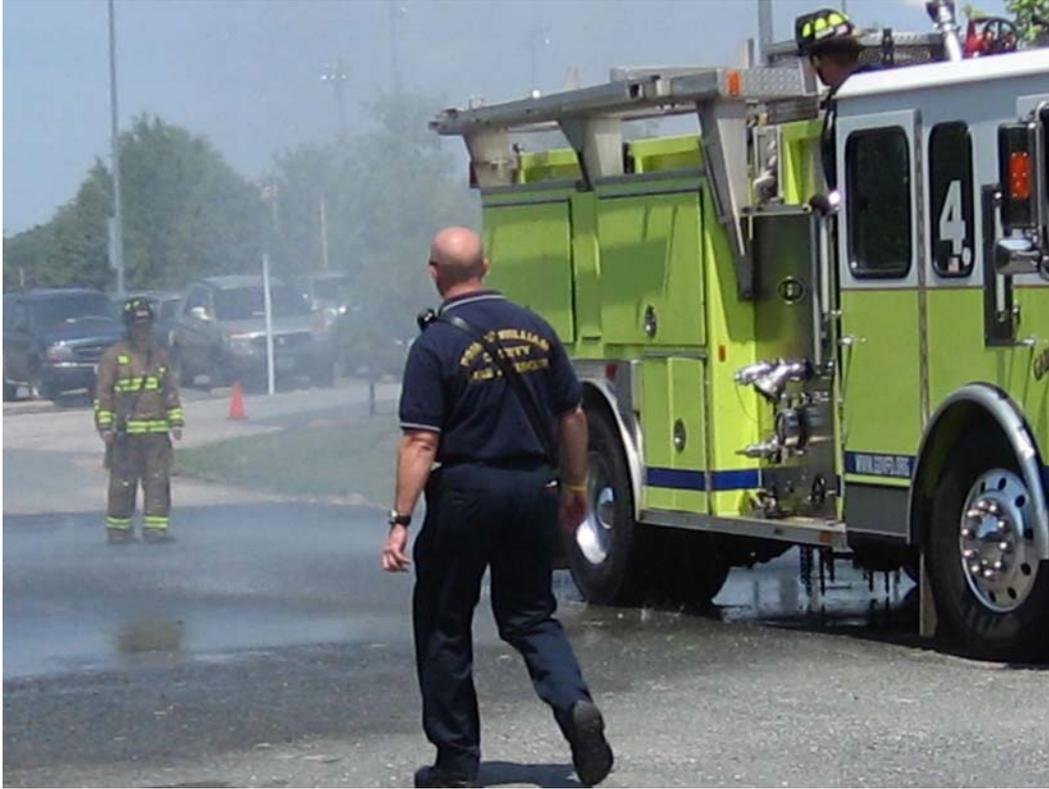
May 22, 2007, Radio Test  
Hydrant pressure through master stream fog nozzle –  
Radios worn over turnout gear – Heavy rain simulation

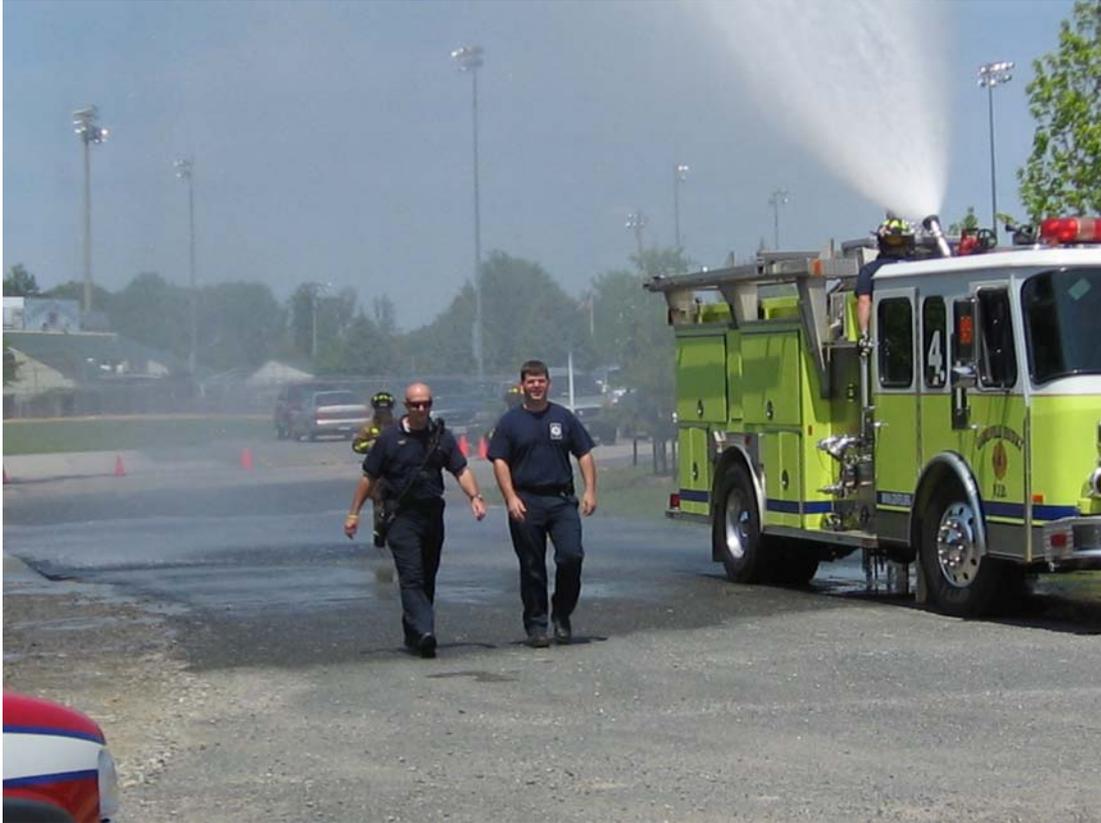
May 22, 2007, Radio Test  
Hydrant pressure through master stream fog nozzle – Heavy rain simulation

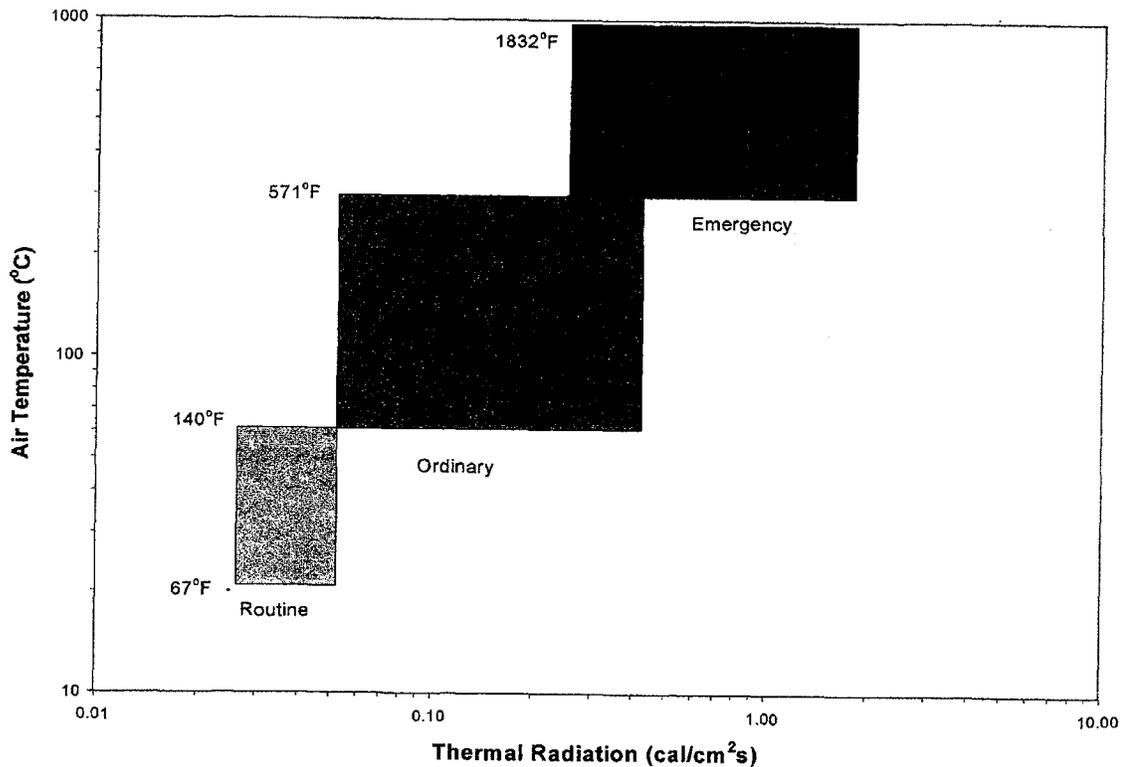
**Figure 46 – Classification of Fireground Conditions**

The fireground event at Marsh Overlook Drive on April 16, 2007 as described would have involved conditions that could be classified in emergency range of exposure. The fire did not start this way, but by the time that [REDACTED] and Technician Wilson were trapped on the second floor, the fire transitioned from the routine to emergency region in a relatively short period time. Under emergency conditions, clothing is only expected to provide tens of seconds of protection to allow the fire fighter to escape. In general, when protective clothing and equipment is exposed to emergency conditions, it becomes damaged. Those components that are most susceptible to damage include trim and the plastic components of helmets. Charring of outer shell textiles in clothing, bubbling of helmet shells, and shrinkage of leather in gloves are typical outcomes for any extended exposure under emergency conditions. The relative damage to protective clothing and equipment will depend on the actual radiant and convective temperatures combined with the length of exposure. It is not so much the temperature of exposure but rather the exposure energy that is received, which is the product of both time and temperature.
